**State of Louisiana
Department of Natural Resources
Coastal Engineering Division**

**2006/2007 Annual Inspection
Report**

**CLEAR MARAIS SHORE
PROTECTION PROJECT
(CS-22)**

State Project Number CS-22
Priority Project List 2

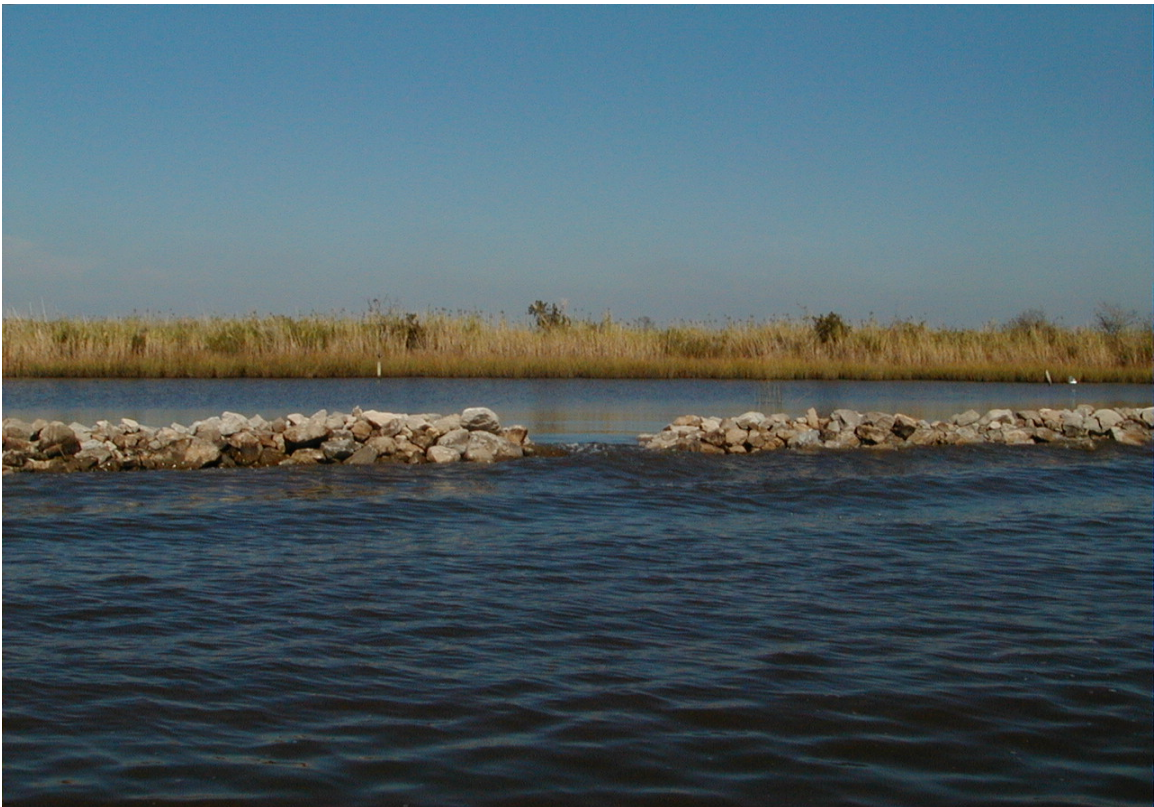
The dike is in fairly good condition. As noted on previous inspections, approximately 4,000 to 5,000 linear feet of dike is slightly below constructed elevation. This appears to be the result of slight settlement rather than displacement. Several of the settlement plates placed during construction are broken/leaning/damaged/ etc. and are no longer useful. One section of dike, approximately 0.5 miles from the Alkali Ditch, has apparently been removed by hunters and or fishermen. This section is only about 4 feet wide with rock removed to an approximate +0.5 NAVD elevation. It has been noted in previous inspections and has not worsened. Three other sections appear to have been displaced by barges nosing up on the bank. This is a problem noted on several other rock dikes along the GIWW. A staff gauge will need to be installed in the vicinity. No apparent need for any other maintenance at this time. (Photos: Appendix B, Photos 1-4)

Photo 2—vandalized area of dike

Overall, the Clear Marais Shore Protection Project is in good condition and functioning as designed with only minor problems noted. Stand pipes on the settlement plates installed on future projects of this type should be much shorter in height. Damage to these plates has apparently been caused by barges or other similar type traffic running in to or tying up to these pipes making them useless for any post-construction settlement information. A much shorter pipe should serve to protect these pipes and/or discourage people from using them as mooring devices. Maintenance recommendations for CY 2007:

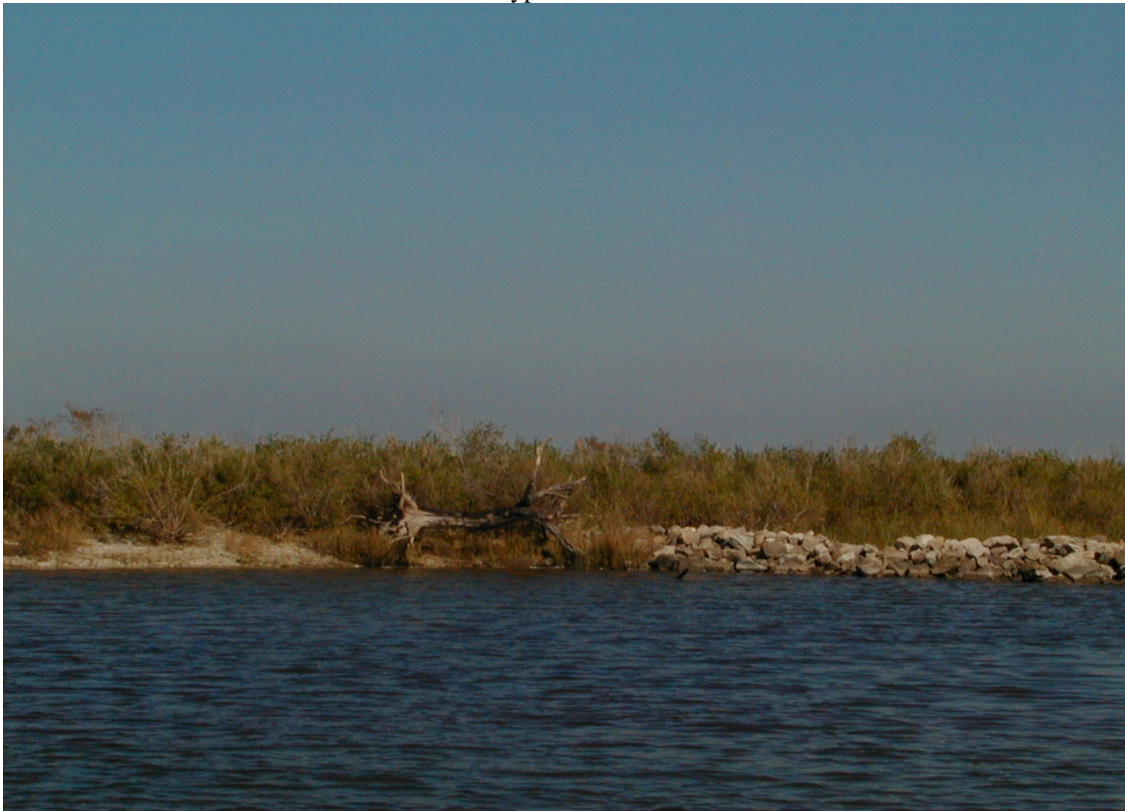
Photo 4—western tie-in of dike
